1. AGENCY USE ONLY (Leave blank)		2. REPORT DATE 1986		3. REPORT TYPE AND DATES COVERED Conference Proceeding 26-30 May 1986
4. TITLE AND SUBTITLE Bird Strike Committee Europe (BSCE) , 18 <sup>th</sup> Meeting, Copenhagen, Denmark 26-30 May 1986. Part I			5. FUNDING NUMBERS

## 18th MEETING

COPENHAGEN, 26 - 30 MAY 1986

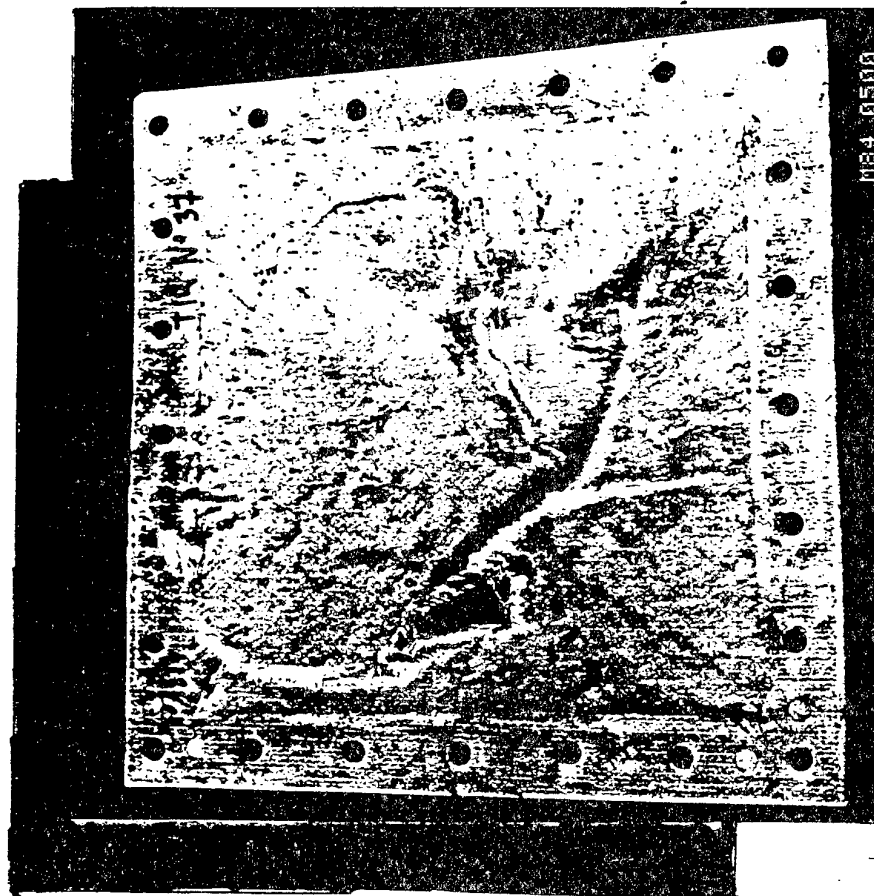
FIGURE 26

FAILURE PATTERN

STAR

BOOK PAGE

Figure 25 shows these failures for the monolithic plates, Figures 26 and 27 for the sandwich plates.
